Bow Lake, Stafford, NH: Water Quality and Cyanobacteria

Presentation Outline

1. Brief Water Quality Summary
2. Cyanobacteria History
3. Cyanobacteria Prevention Strategies
4. Statewide cyanobacteria plan preview

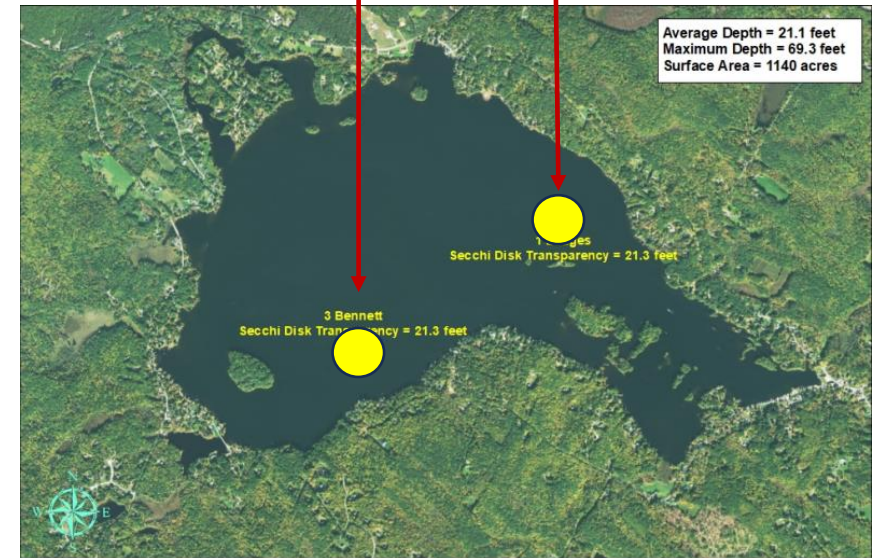
2 Deep spot locations:
Station 1- Ledges
Station 3 - Bennett

+ Nearshore sites (24 in 2022)

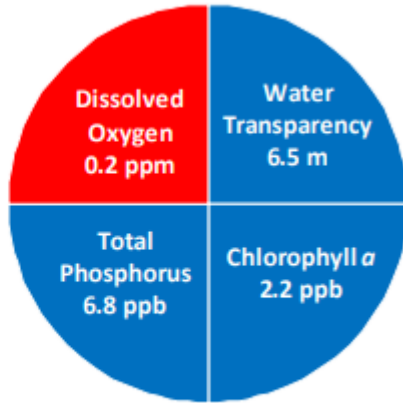
Figure 1. Bow Lake Water Quality (2022)

Station 1 - Ledges

Blue = Oligotrophic
 Yellow = Mesotrophic
 Red = Eutrophic
 Gray = No Data

Deep spot water quality summary

- Water transparency > NH avg. for oligotrophic lakes (4.5m)
- Chl a = NH avg. for oligotrophic lakes (2.5 ppb)
- TP = NH avg. for oligotrophic lakes (6.7 ppb)

Long Term Trends

- Water transparency = 5 – 8m
 - Chl a = 1 – 3 ppb
 - TP = 6 – 8 ppb
- No major changes over time

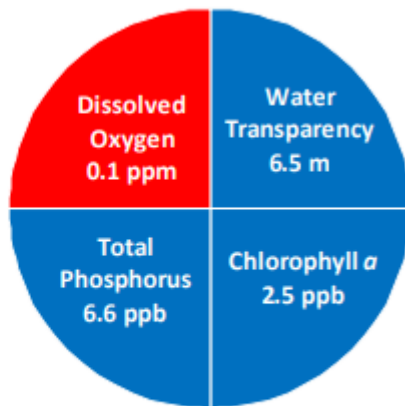
Figure 1. Bow Lake Water Quality (2022)

Station 3 - Bennett

Blue = Oligotrophic
 Yellow = Mesotrophic
 Red = Eutrophic
 Gray = No Data

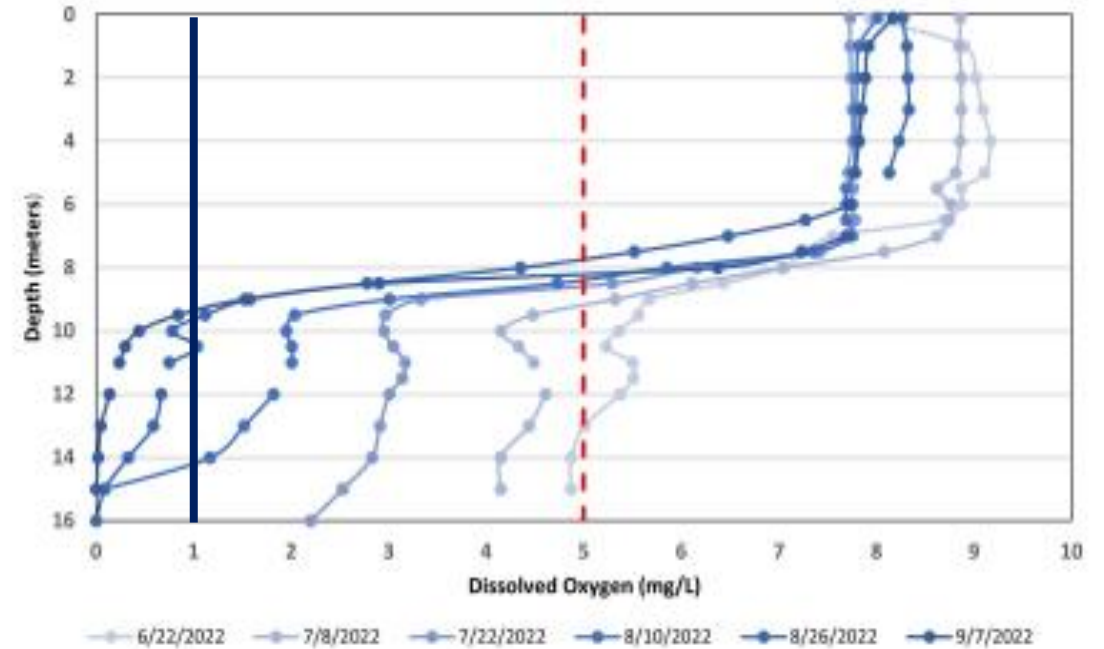
Figure 7. Bow Lake - Site 3 Bennett
Dissolved Oxygen Profiles (June 22 through September 7, 2022)

Dissolved Oxygen – Ledges & Bennett

- DO < 5 ppm (red vertical line) does not support fish for extended periods (~8m by mid-summer).
- DO < 1 ppm (black vertical line) allows phosphorus to be released from bottom sediments (9-10m by late summer).

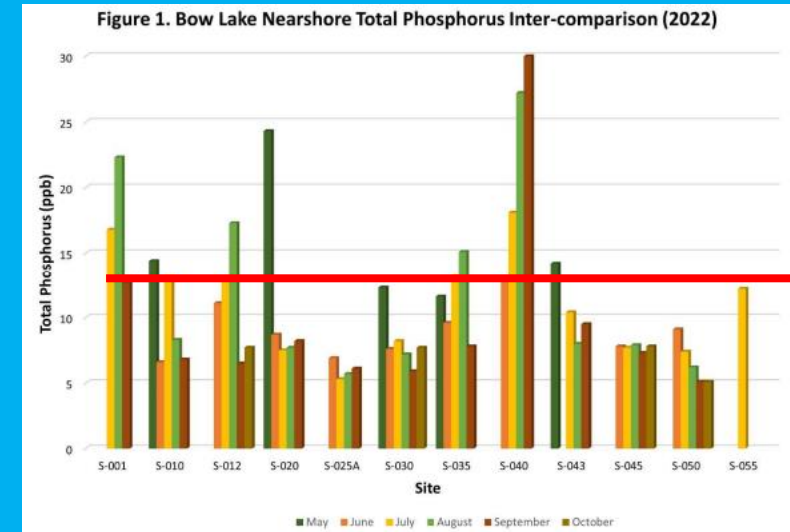
- Most sites between 5 – 10 ppb
- Some sites >12 ppb (eutrophic)

= 12 ppb

- Sample locations in “bays” tended to have higher phosphorus concentrations and may be more susceptible to nutrient loading or cyanobacteria blooms
- Sample locations in less “protected” areas had lower phosphorus concentrations
- Stormwater management projects are important to control runoff into the lake

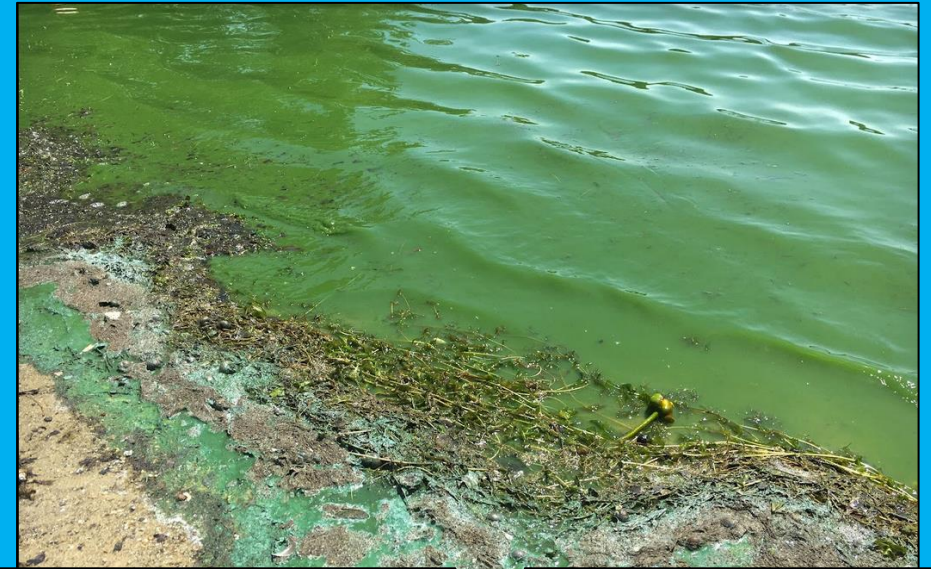
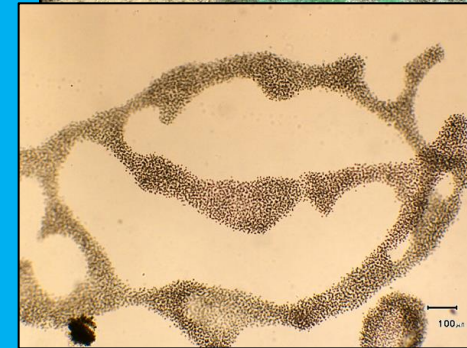
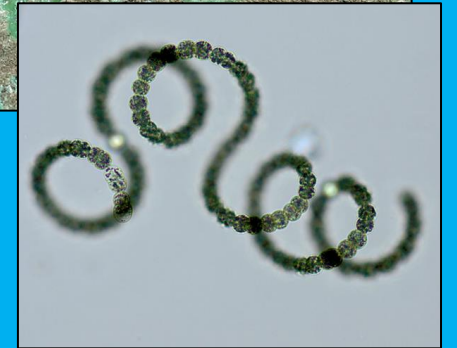
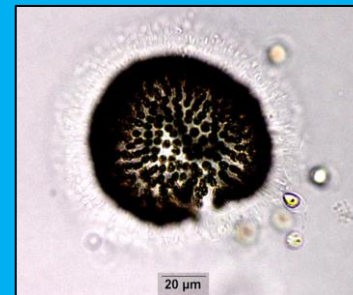
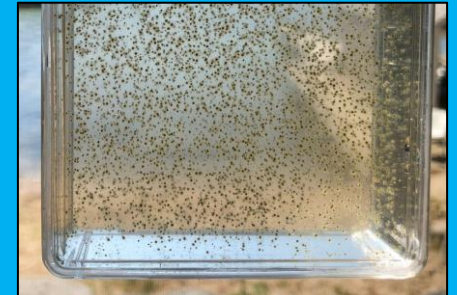
- Originated 3.5 billion years ago
- Microscopic
- “Native” to NH lakes
- Previously called blue-green algae
- Can produce toxins that cause nausea, skin irritation, tingling, numbness, seizures, and promote tumor growth

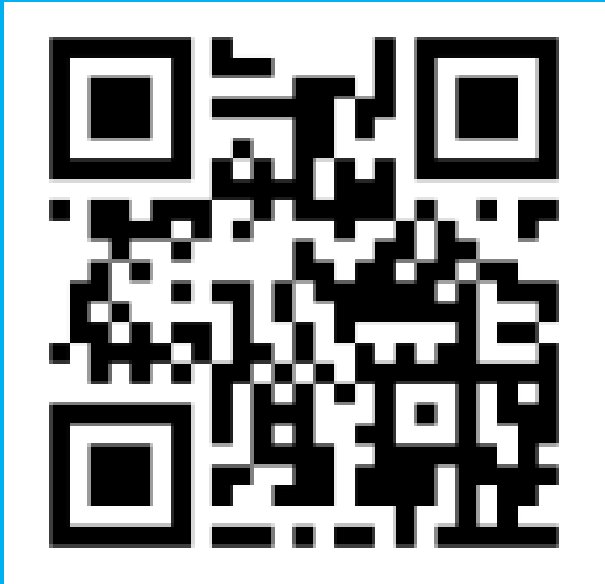
Cyanobacteria Bloom Report Form

- Consistent format for reporting blooms to NHDES
- Response is typically within 24 hours
- Allows pictures of bloom to be included in report

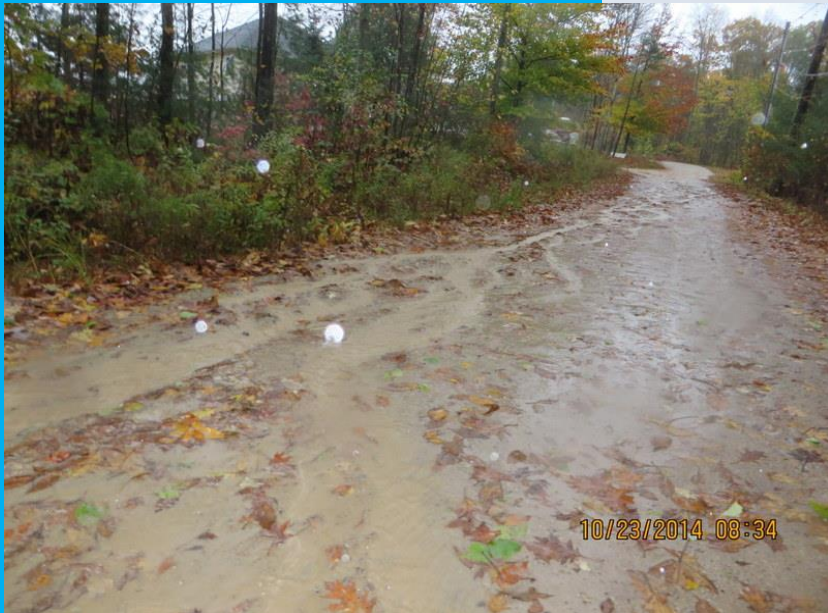
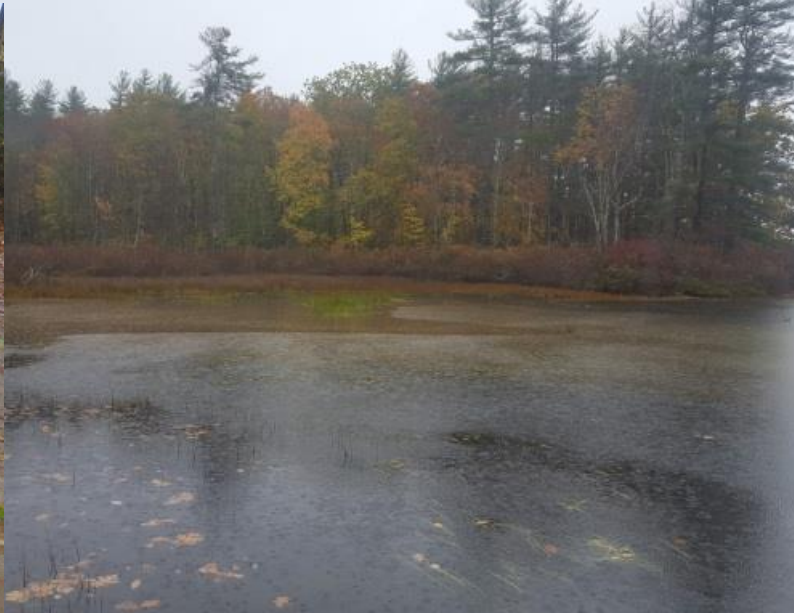
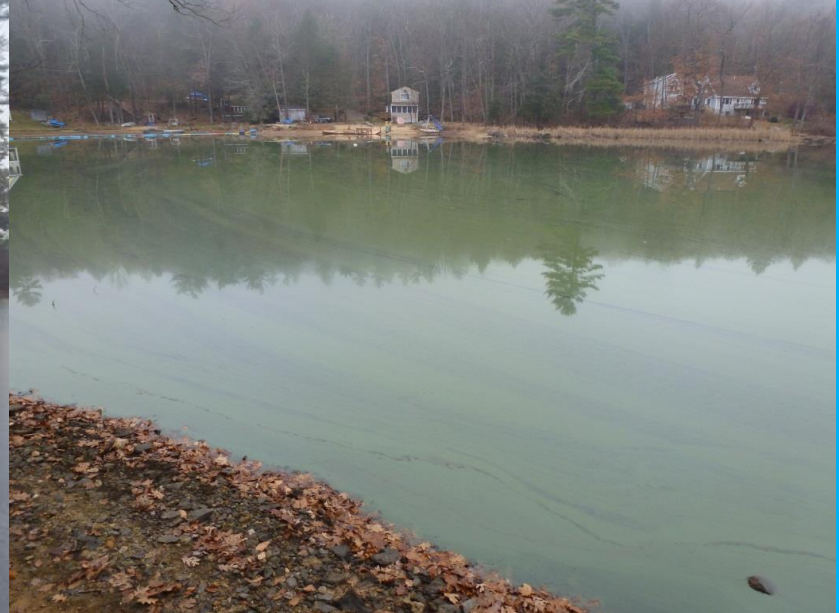
- Unmanaged Stormwater is the number #1 cause of excessive nutrient loading
- Lake bottom sediments can contribute large nutrient loads when dissolved oxygen is <1 mg/L
- Fertilizers contain lots of nutrients (nitrogen and some phosphorus)
- Failing/old/unmaintained septic systems can contribute unnecessary nutrient loads
